## Inspection Advisory

Dyna-Lock<sup>®</sup> Self-Retracting Lanyard – 20ft. Models

August 6, 2008

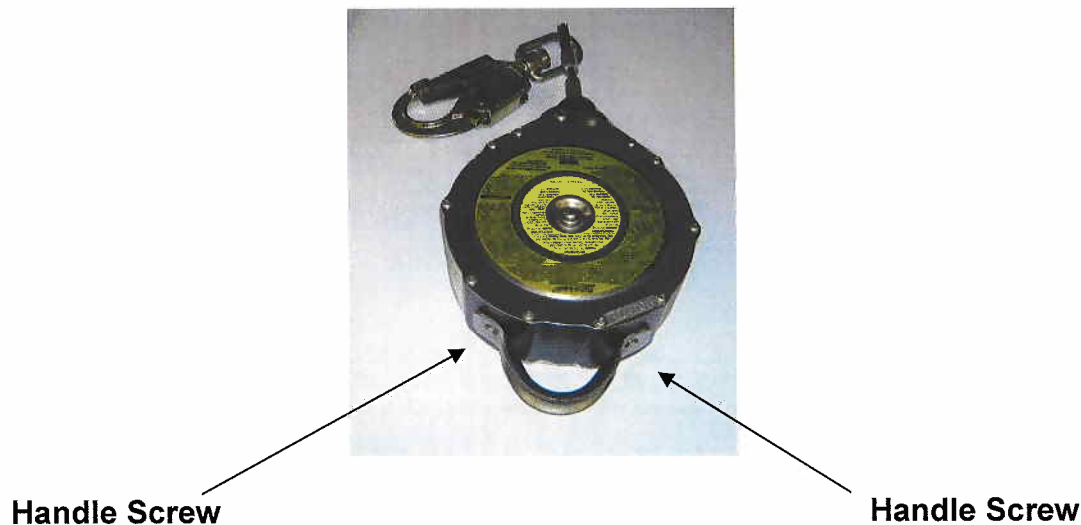
MSA recently received a report that the attachment handle on a 20 ft. Dyna-Lock Self-Retracting Lanyard (SRL) became loose and separated from the unit. Although the user was not injured, our inspection of the unit revealed that the ends of the two screws securing the handle were not swaged (flattened) as intended by our housing/handle supplier. The swaging process prevents the screws, which are installed from inside the housing, from unthreading. If a handle screw unthreads due to vibration or other means, the handle could detach from the housing and cause the SRL to separate from the anchorage resulting in loss of fall protection.

As a result of this report, we inspected other SRLs that utilize the same or similar handle design and found less than 5% of the units inspected contained handle screws that were not swaged. All of the units found with unswaged handle screws were manufactured or last serviced between October 2007 and June 2008.

The photo below identifies by the arrows the location of the two handle screws to be inspected:

**As a result of this finding, MSA requests that users receiving this Inspection Advisory immediately inspect the 20 ft. Dyna-Lock SRLs in their possession to determine if the screws securing the handle are swaged. Any units with unswaged screws (one or both) must be removed from service and returned to MSA for repair. The repair and the shipping are free of charge. Units not exhibiting this condition may remain in use.**
